CIVIL AERONAUTICS BOARD

ACCIDENT INVESTIGATION REPORT

AMERICAN AIRLINES, INC., AND U. S. NAVY, COLLISION NEAR
PORT COLUMBUS AIRPORT, COLUMBUS, OHIO, JUNE 27, 1954

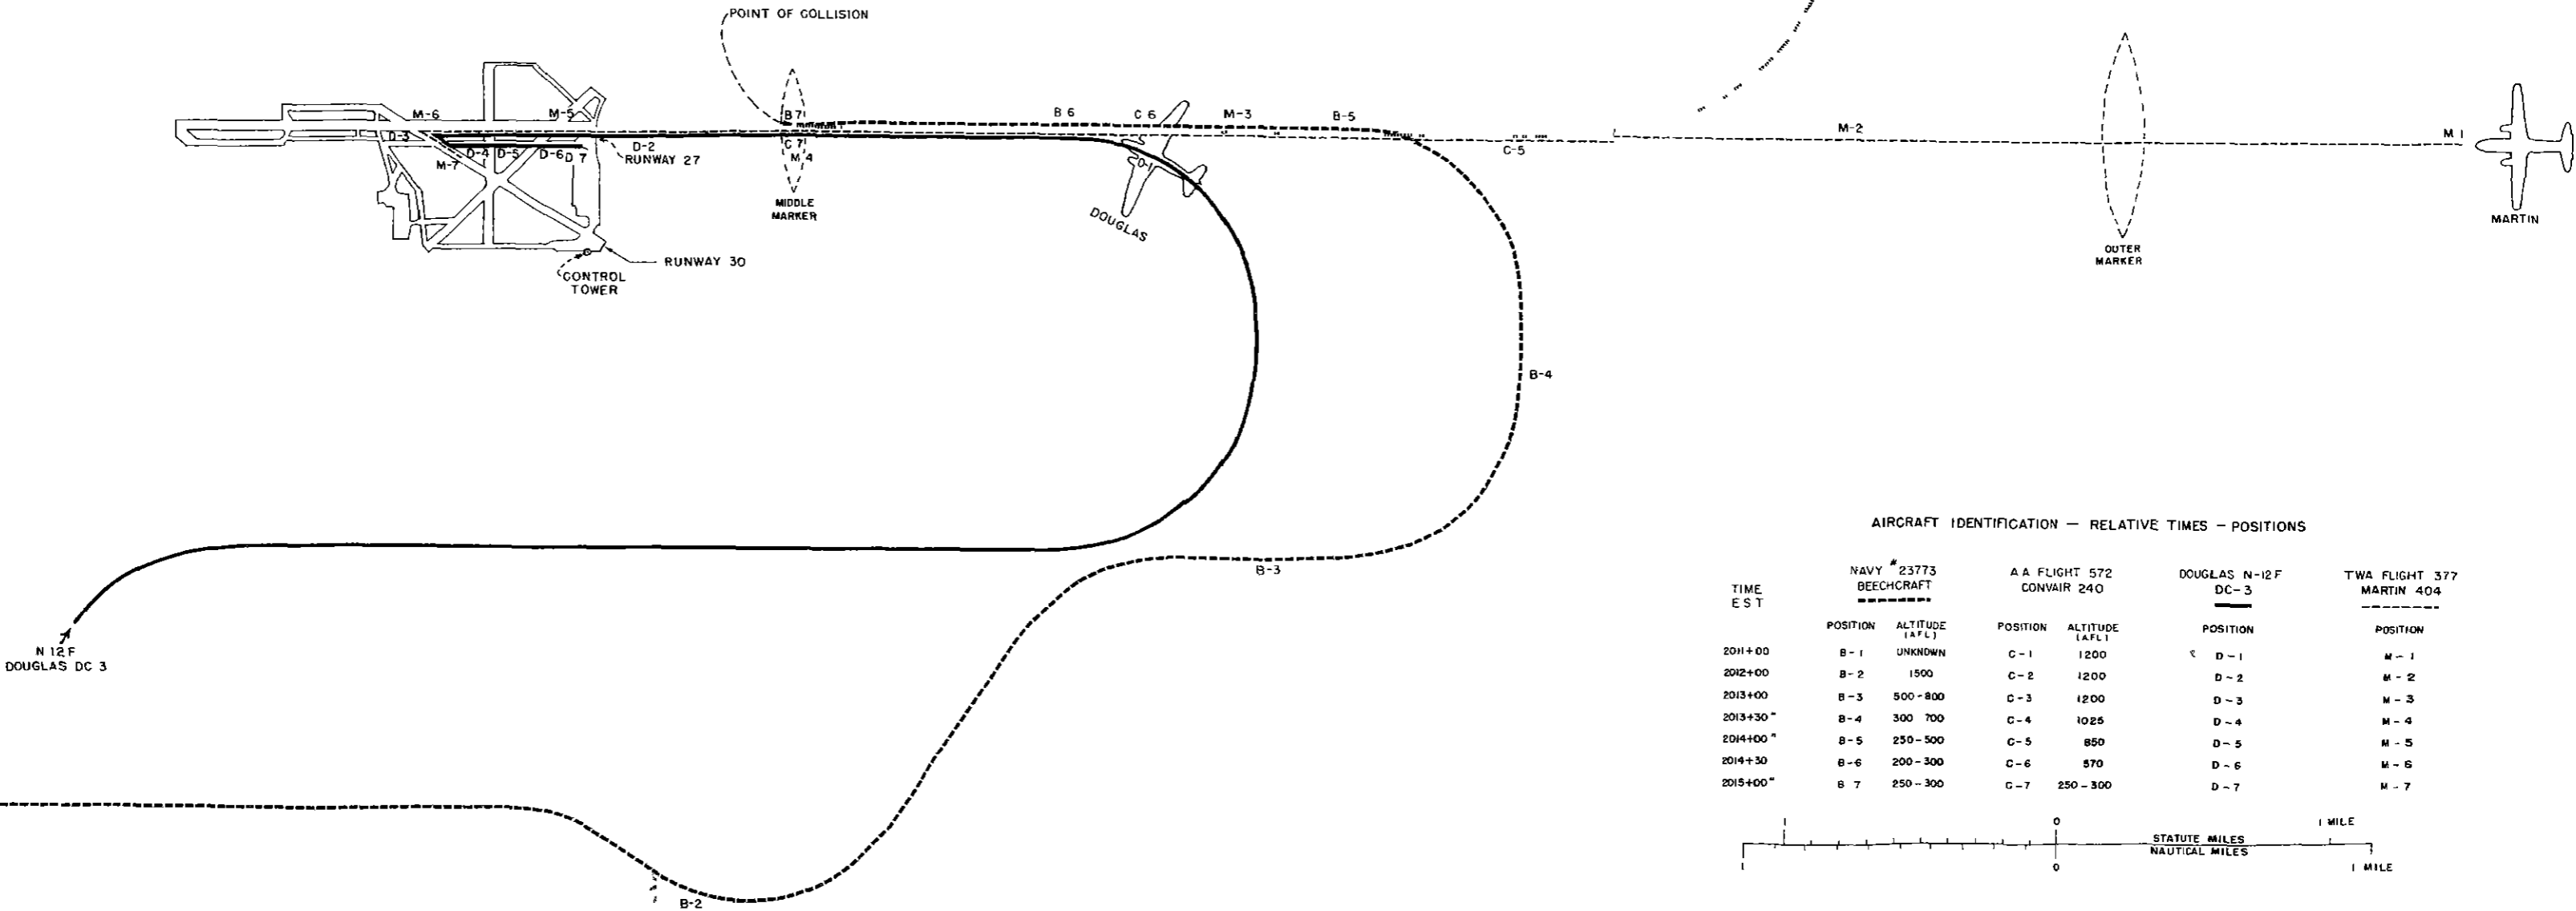
ATTACHMENT A

The tower was located in the southeast corner of the airport and the runways were as shown in attachment A. Several qualified witnesses stated that the tower was considered marginally adequate. They stated it was originally constructed as a weather observation tower and was not as high as desirable. The windows consisted of approximately 140 small panes of glass with divisions between each. There were eight one-foot wide concrete support columns equally spaced around the octagon-shaped structure and one large solid entrance door in the south wall. A radar installation covered with a canvas tent had been added to the tower several months before the accident. These conditions required the local controller, whose position faced north, to stand and move continuously while observing airport traffic. At the time of the accident a new tower was being constructed.

The investigation included a careful study of the flight paths and position reports of the four principal aircraft which were flying in the Port Columbus traffic pattern during the accident period. These factors together with witness testimony were incorporated into an engineering study, attachment A, and indicate the probable flight paths of the aircraft which collided

as well as the TWA Martin and the Douglas DC-3 which preceded them. Considering all available data and the probable flight paths a study was made to determine so far as possible the visual limits of each crew member afforded by the cockpit structure of the Convair and SNB. The limits were applied to each crew member throughout the last two minutes of the flight path in consideration of the aircraft attitudes. It was learned that the SNB first entered the cockpit angular limits of vision for the Convair captain when the Convair was on the base leg. At this time the SNB was approximately 40 degrees to the right of the Convair's longitudinal axis and was about 3 miles away. The SNB remained within the visual limits of the captain's position until both aircraft were on the final approach and the Convair was approximately 1/2 mile behind the Navy aircraft. The total time that the SNB was in the visual limits of the captain's position was approximately 1-1/4 minutes. At the start of this period the SNB blended into the horizon and then continued below it for the remaining time.

PROBABLE FLIGHT PATHS OF AIRCRAFT IN RELATION TO PORT COLUMBUS AIRPORT
